# **INDOOR AIR QUALITY REASSESSMENT**

**Amesbury Town Hall  
86 Friend Street  
Amesbury, Massachusetts**

Prepared by:  
Massachusetts Department of Public Health  
Bureau of Environmental Health Assessment  
Emergency Response/Indoor Air Quality Program  
January 2003

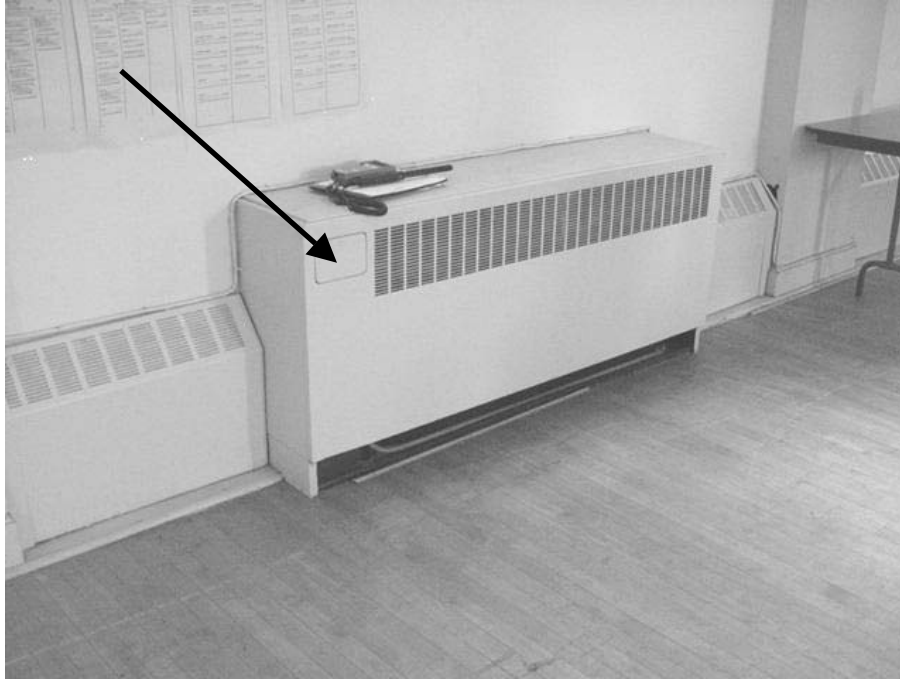
**Picture 1**

BEHA staff however, noted several unit ventilators (univents) located on the exterior walls of the meeting room (see Picture 1), which appeared to have not been activated for some time. Univents draw air from outdoors through a fresh air intake located on the exterior walls of the building (see Picture 2) and return air through an air intake located at the base of each unit (see Figure 1). Fresh air and return air are mixed, filtered, heated and provided through a fresh air diffuser located in the top of the unit. In order for univents to provide fresh air as designed, they must be activated and allowed to operate. Airflow is controlled by a toggle switch located on the front of the unit behind an access panel (see Picture 3). In subsequent conversation with local health officials, a plumbing contractor was reportedly contacted to determine the operability of the univents.

**Abandoned Unit Ventilator in Auditorium (One of Two)**

4. Continue with plans to hire a plumbing or heating contractor to examine abandoned univents in auditorium for function. If operable, operate units during periods of building occupancy. Examine units to determine if they are equipped for filtration. If so, change filters on a regular schedule (e.g. 2-4 times per year).

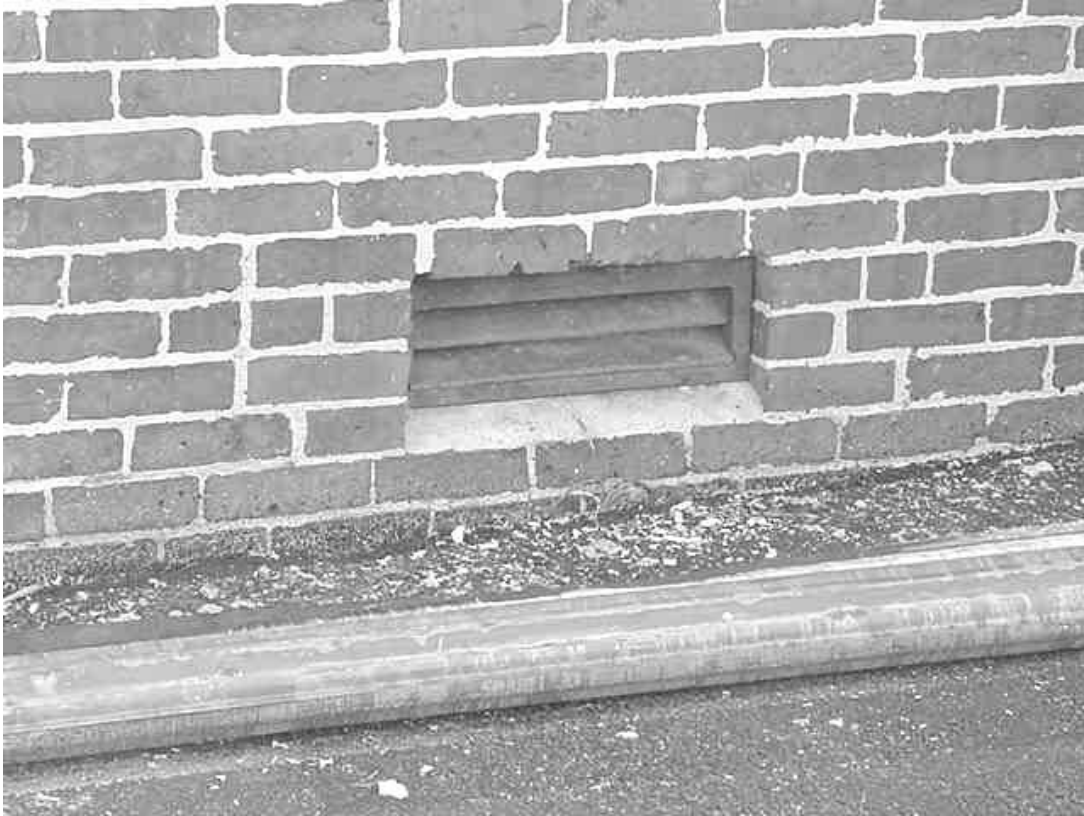
**Picture 2**

**Univent Fresh Air Intake on Exterior Wall of Building**

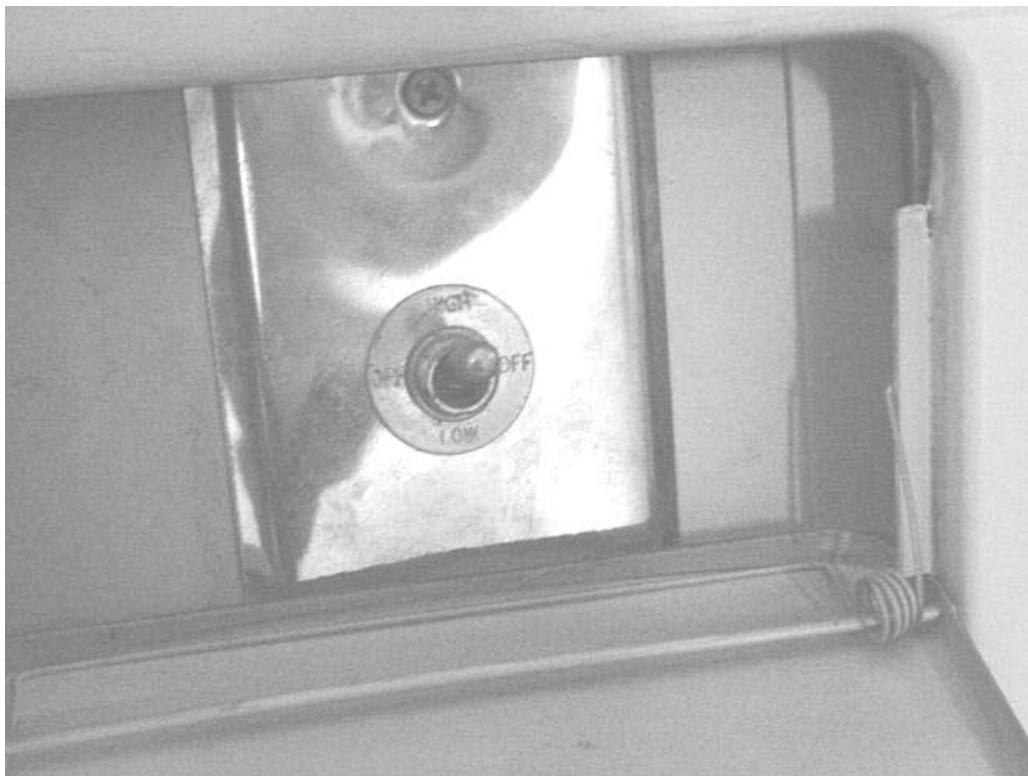
**Picture 3**

**Toggle Switch Controlling Univent Airflow**

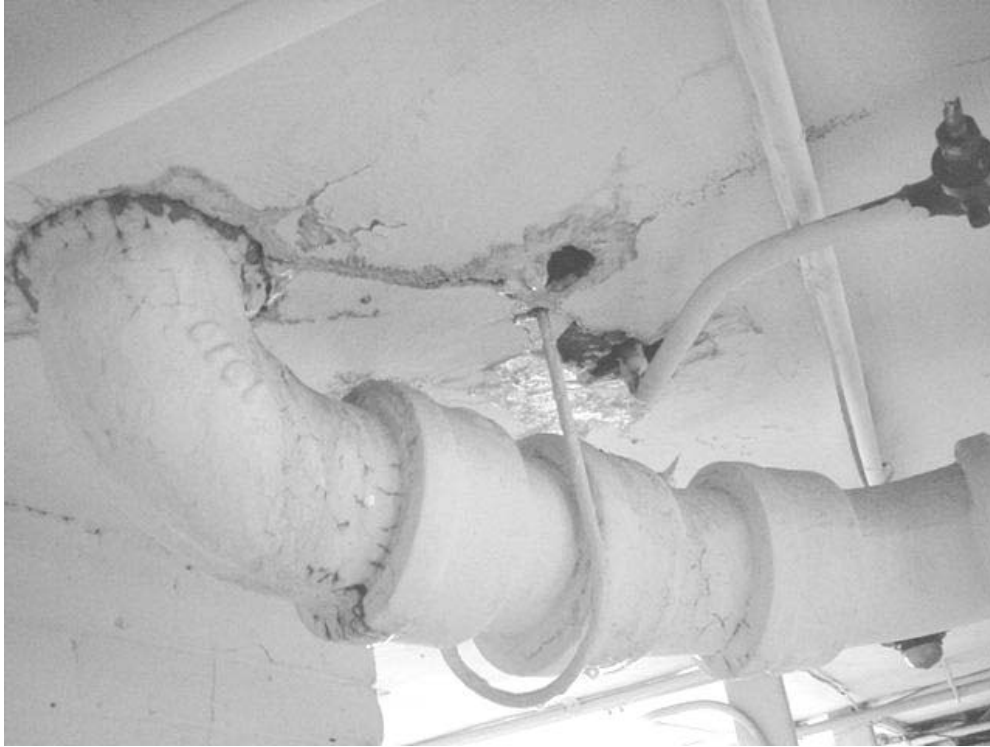
**Picture 4**

A leaking pipe was observed in the basement men's restroom (see Picture 4). Water damaged ceiling plaster was also noted around this area. If porous materials are allowed to remain moistened for an extended period of time, mold growth may occur. The American Conference of Governmental Industrial Hygienists (ACGIH) recommends

that porous materials be dried with fans and heating within 24 hours of becoming wet (ACGIH, 1989). If porous materials are not dried within this time frame, mold growth may occur. Water-damaged porous materials cannot be adequately cleaned to remove mold growth. The application of a mildewcide to moldy materials is not recommended.

**Leaking Pipe and Water Damaged Ceiling Plaster in Basement Restroom**

1. Continue to implement recommendations made in the previous BEHA report (MDPH, 2001).
2. Repair leaking pipe in basement restroom. Replace any water damaged building materials. Examine the area above and around these areas for mold growth. Disinfect areas of water leaks with an appropriate antimicrobial.

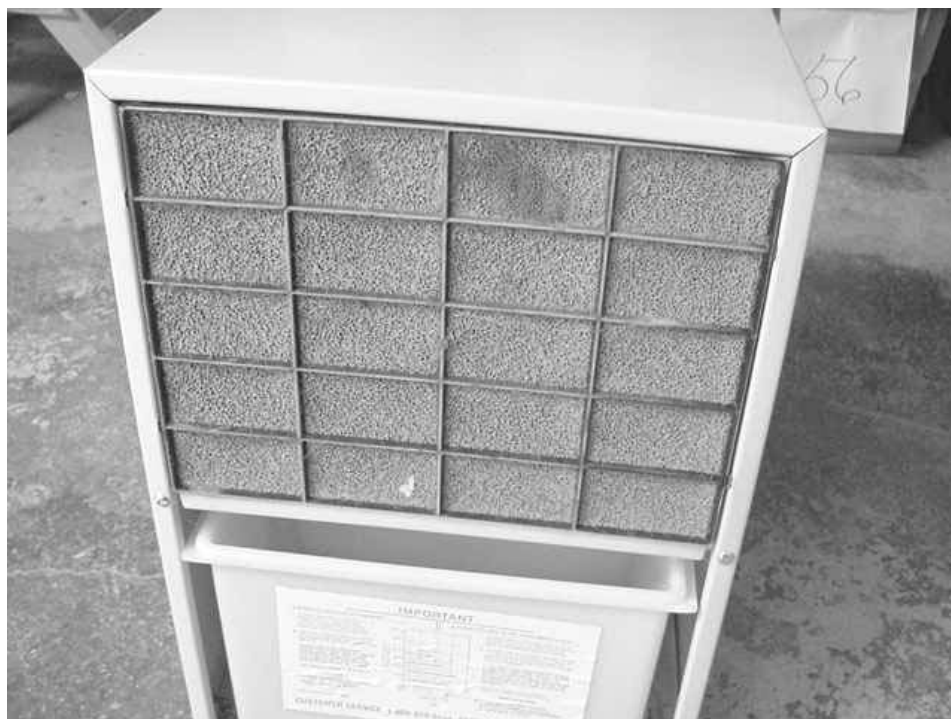
**Picture 5**

Dehumidifiers were being used in the basement and air purifiers were in use in office spaces. These types of equipment are usually equipped with filters that should be changed as per the manufacture's instructions. The filter for the dehumidifier in the basement was occluded with dust and debris (see Picture 5), which can become reaerosolized with operation.

**Dehumidifier Filter Saturated With Dust and Debris**

3. Clean change filters for air purifiers, window mounted air conditioners and dehumidifiers as per the manufacture's instructions or more frequently if needed.

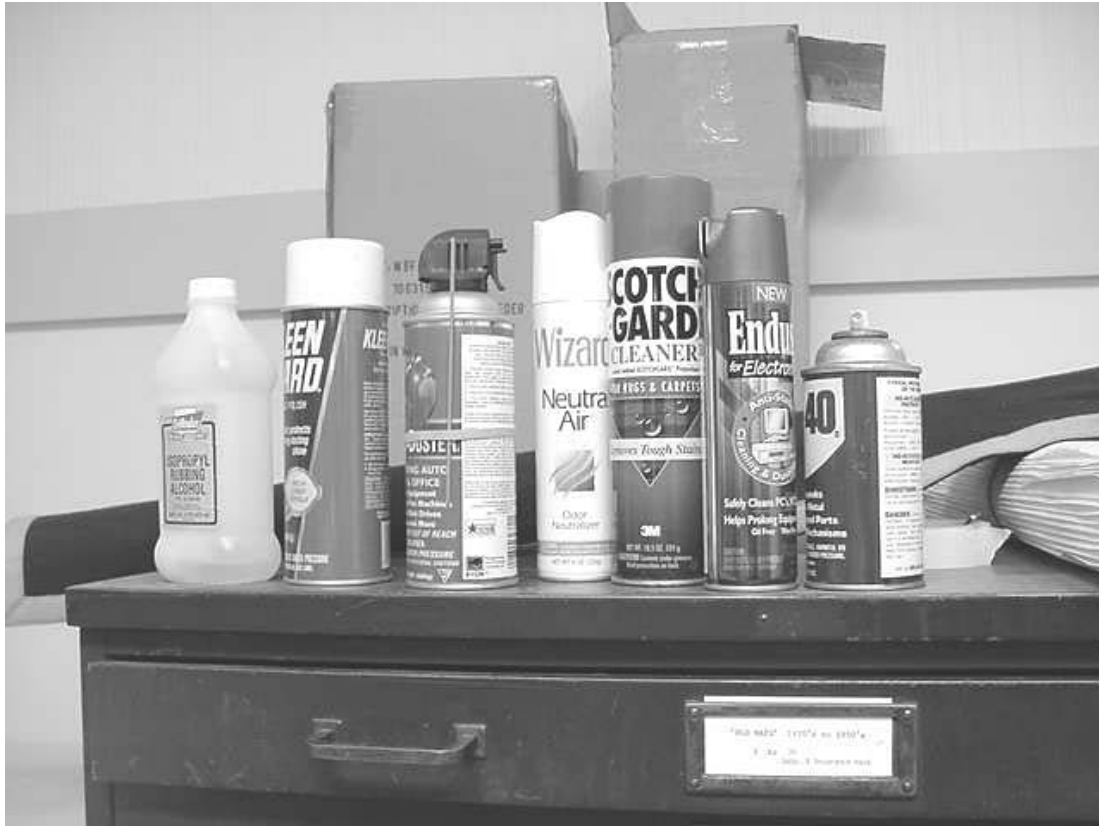
**Picture 6**

Another potential source of irritants is the use of different cleaning products (see Picture 6). Several types of cleaning products were observed in various areas. These products contain volatile organic compounds (VOCs) or other materials that can be irritating to the eyes, nose and throat. Exacerbating odors from the use of these materials is the lack of mechanical ventilation within the building.

**Clean Products/Solvents in the Community & Economic Development/Planning Office**

5. Avoid using custodial cleaners containing VOCs. Acquire current Material Safety Data Sheets for all products that contain hazardous materials and are used within the building, including office supplies, in conformance with the Massachusetts Right-To-Know Law, M.G.L. c. 111F (MGL, 1983).

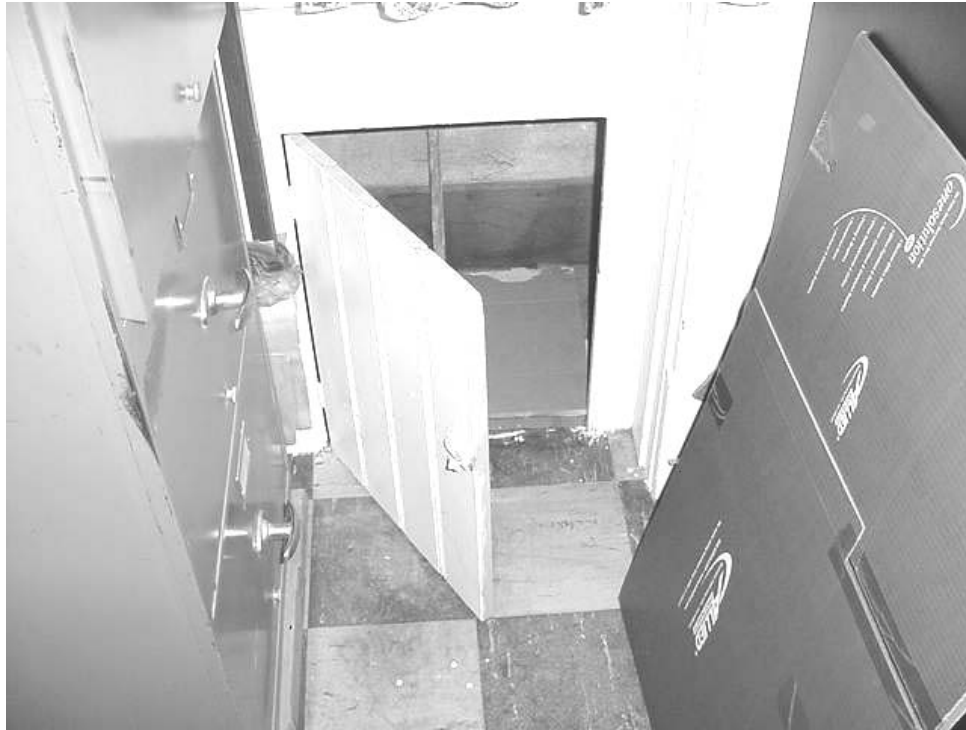
**Picture 7**

**Abandoned Sink Cabinet Door in Town Clerk's Office**

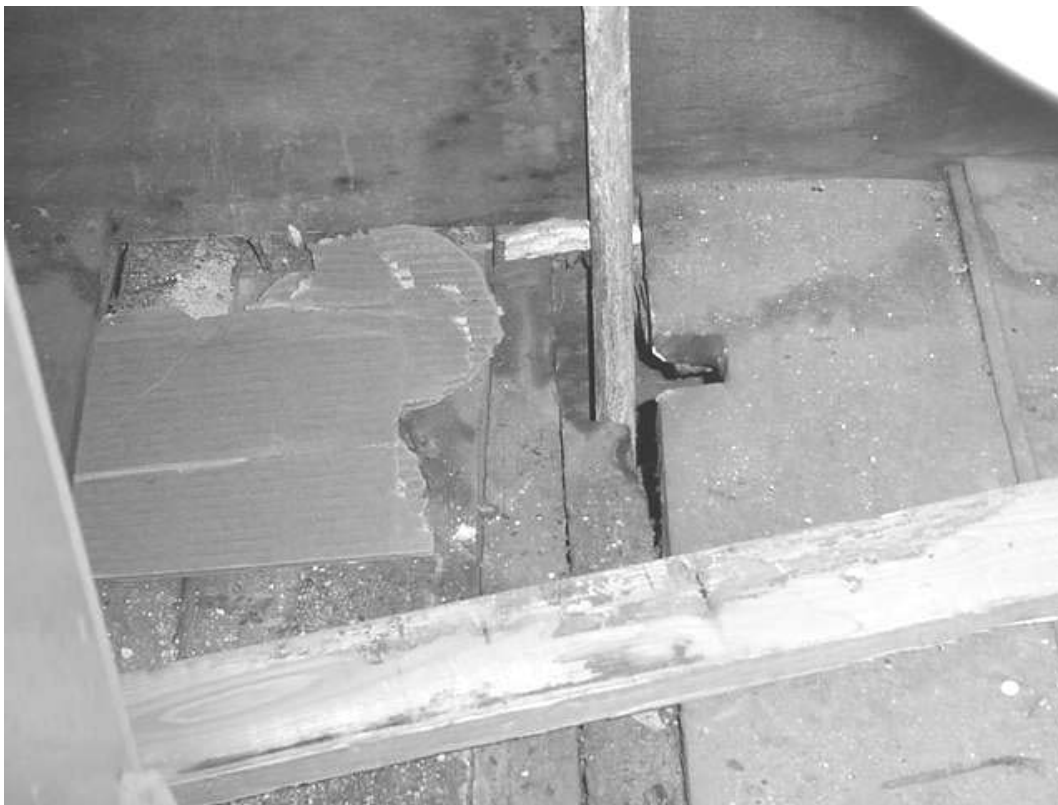
**Picture 8**

Musty odors were reported in the town clerk's office. The origin of these odors was a cabinet at floor level (see Picture 7). BEHA staff examined the interior of the cabinet and found an open floor hole leading to the basement covered with cardboard (see Picture 8). Open floor and/or utility holes can provide pathways for the movement of drafts, dusts and particulate matter between rooms and floors.

**Open Hole to Basement in Cabinet Shown in Preceding Picture**

6. Seal hole beneath cabinet in Town Clerk's office and any other utility holes (see Tables) to prevent the migration of basement odors.
